SOLAR DECATHLON CHALLENGE 2022
DESIGN NARRATIVE

RETROFIT HOUSING

ENGLISH AVENUE YELLOW JACKETS

GEORGIA INSTITUTE OF TECHNOLOGY

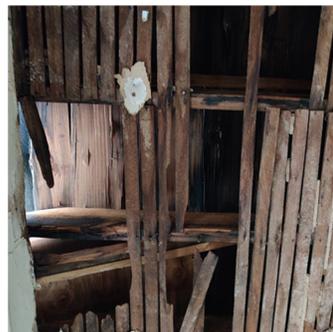
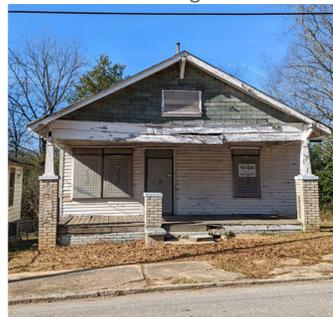
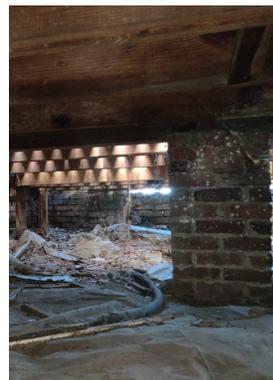
Figure 5: Existing condition of the house

Inspection 1: There was a clear foundation settlement in the west part of the building. Measuring from the corner post, @ 10' is where the settlement starts. Although it is just 1.56" at its settlement point, it is essential to check the foundation's condition. At the south/back part of the building's highest settlement point is 3.23". This settlement was created because of faulty plumbing that led to moisture exposure to the foundation, leading to the formation of cracks and subsequent settlement. The eastern part of the building is perceived as in pristine condition, but there is a settlement at the junction post where it meets the northern part of the building. There was clear moisture infiltration by the soil around the foundation, and it had started to affect the subsoil structures. This can lead to further repairs and costs. The stairs coming out of the kitchen to the backyard were unstable and would need to be demolished.

Conclusions: The foundation needs to be lifted by anchors in a total of 11 places in the western (4), southern (4), and eastern (3) parts of the building. There is also a need to clear all old systems out of the crawl space. The crawl space needs moisture treatment as there are increased levels of water seepage throughout the perimeter. The wood joist floor will need further inspection and lab testing to accurately evaluate moisture damage. Any additional piers added to the foundation would require steel shims and dampers to counter any future foundation settlement. There is water standing or running alongside the foundation as the neighborhood seems to be flood-prone, and there are not enough slopes provided around the foundation for it to be a natural waterway. A sloped area around the foundation will help minimize water infiltration into the foundation, hence increasing the life of the structure. Extreme care needs to be taken by the contractor when taking out the existing settled foundation walls.

Ceiling

Front porch

Crawl space

Inspection 1: The initial inspection clearly showed signs of disintegration in the southern parts of the exterior façade. One of the key elements is that most of the external siding was found to be bowing. This, accompanied by the paint coming off most of the siding, added to the concerns regarding salvageable materials. On the western part of the façade, there was significant weed growth going all the way to the roof and foundation outside the bath. There were clear holes around the areas of the windows on the eastern side of the building, which created an energy liability. Ceiling joists and roof joists

Conclusion: The exterior siding needs to be replaced. It can be reused to make furniture for the house. Certain sections of the interior need to repair by changing the lath section. It is highly recommended to have a fresh layer of plaster. A change of 60% plaster lath from the damaged corner for any room with a damaged area of more than 20% of the total area. Electrical wires need to be safely boxed, and the location of boxes (outlets) needs to be marked for future reference. Salvageable wood siding can be used to make furniture and outdoor chairs for the front and back porch.

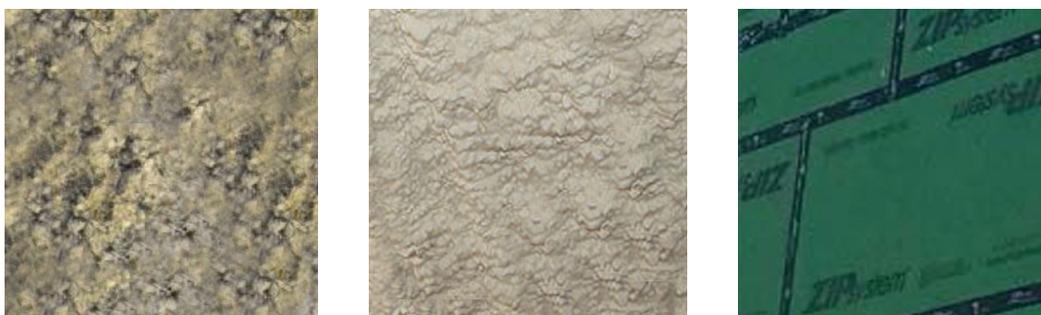
Figure 15: Dense Pack cellulose, Closed-cell spray foam, ZIP system wall sheathing

Location	Product Name	Product Type	Product Features
Foundation	FOAM-LOKTM 2000-4G closed cell spray insulation	Closed-cell spray foam	Extremely low GWP, Superior air-sealing performance, long term durability.
Wall Assembly	ZIP System wall sheathing	Mineral wool board	One less building material (integrated WRB) has superior air sealing performance.
Ceiling	AFT Carbon smart loose-fill cellulose insulation	Dense pack cellulose	+23% improvement on ODP, +16% improvement on GWP, ease of installation.

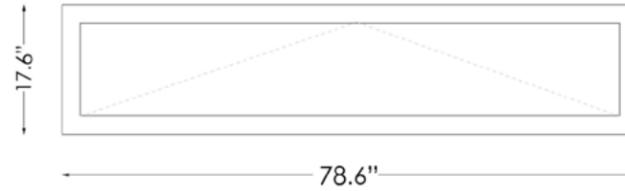
W4: Ribbon hinged window, Low E, double pane

U Value (IP)– 0.27
SHGC – 0.21
VLT – 0.49

Ribbon windows, famously noted for in the Villa Savoye, are taken inspiration from and are placed to enable privacy and, at the same time, formulate a daylighting strategy that paints a stream of direct and reflected light into deeper sections of the house. Selectively framing daylight designs helps in customization based on the type of climate. The sun angle is 79.8° in summer and 32.8° in winter in Atlanta. The roof overhang prevents the entry of direct rays and decreases concerns of overheating due to the summer sun. On the other hand, the winter sun is less harsh and is let in through the windows at eye level while controlling glare through blinds. These strategies maintain daylight

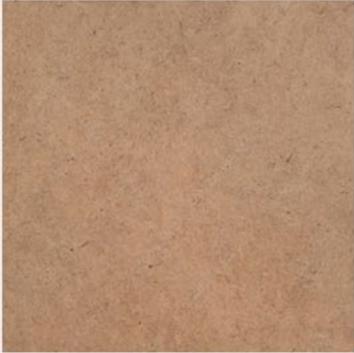
<p>Medium density fiberboard core</p>	<p>Description: Formaldehyde-free(NAF) MDF – FSC certified</p> <p>Board: 100 lb per ¾” panel, 4x6x1/8” (l x w x t), primed finish</p> <p>Application: Paneling, kitchen and bathroom cabinet(least affected by humidity, temperature changes), AFM Safecoat Durostain sealer</p>

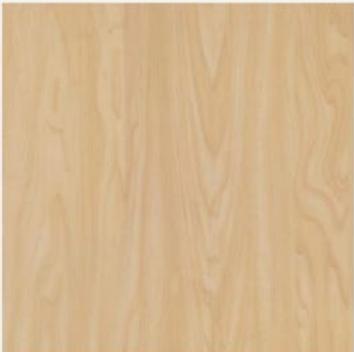
<p>Maple laminate</p>	<p>Description: Urea formaldehyde-free(NAUF) – FSC certified</p> <p>Board: ½” Laminated board – cabinet face, 5/8” shelving and storage</p> <p>Application: Cabinets</p>
